TIM VAUGHAN
RACING

Pant Wilkin Stables, Aberthin

Water Balance Assessment

July 2022

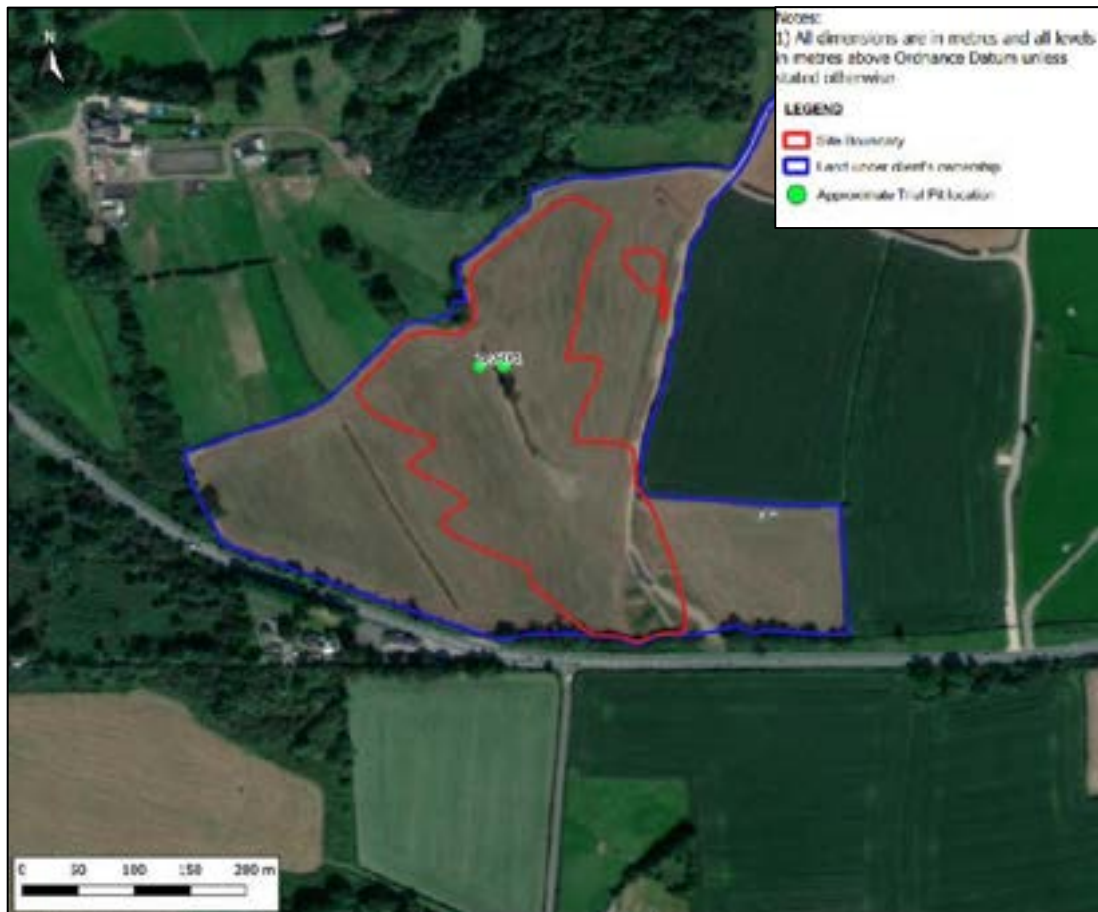
Figure 1 – Approximate Trial Pit Location Plan

In total, two trial pits (TP1-TP2) were excavated, these locations were chosen based on hydrological considerations, topography and site layout. A map showing the approximate trial pit locations is provided within Figure 1 below:

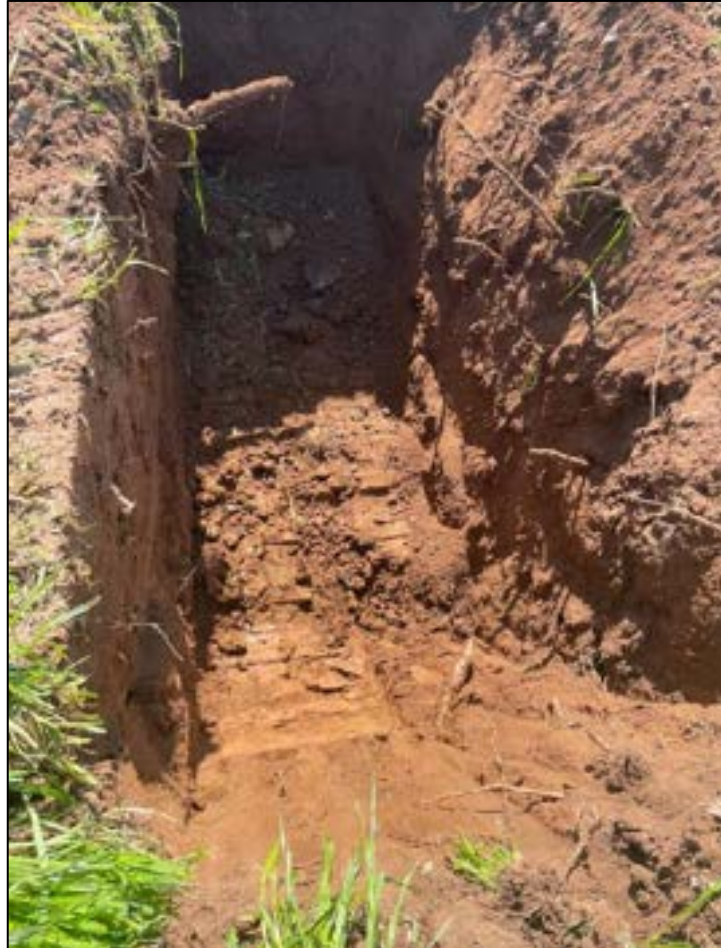
Figure 2 – Photograph showing the inside of TP1

The first trial pit was excavated to approximately 2 metres below ground level (m.bgl). The topsoil was generally a strong red-brown colour which became increasingly silty and clayey with depth. The clay close to the lowest point was discontinuous, as evidenced by the intermittent smears from the excavator bucket. There was no sign of gleying or mottles which would indicate periodic waterlogging. Very few stones were seen in the soil and no bedrock was found. No indication of groundwater was seen.

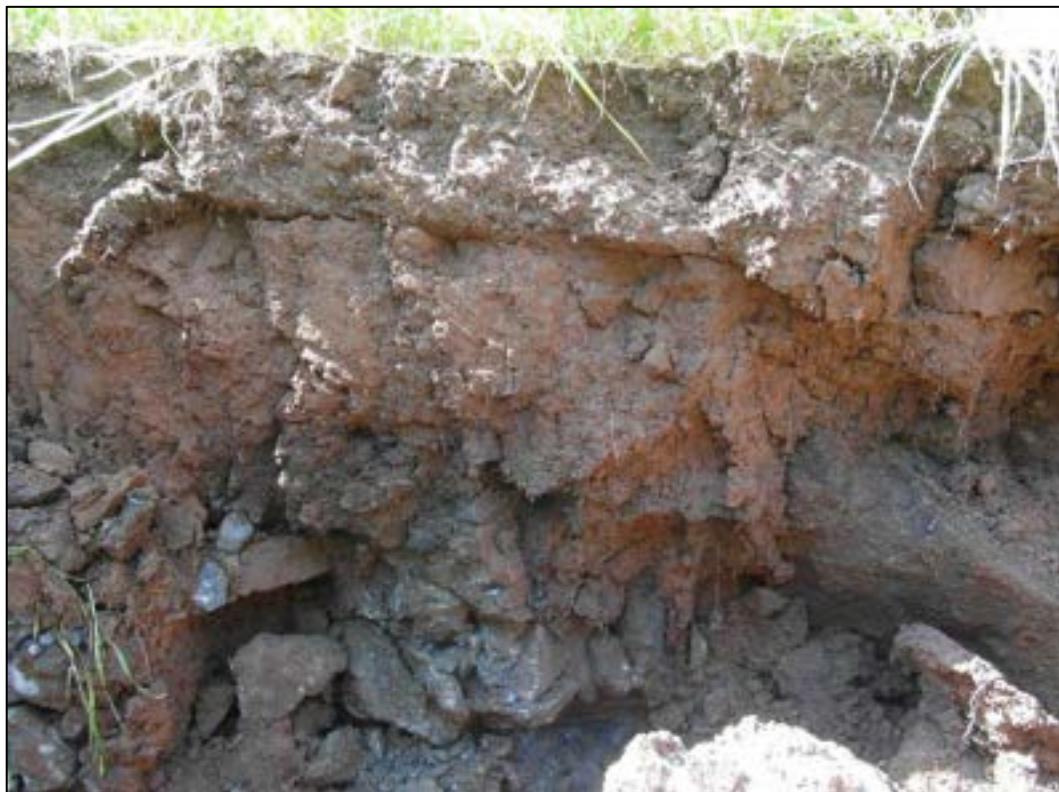
Figure 3 – Photograph showing the inside of TP2

The second trial pit was located within the area known to pond during heavy rainfall events. The trial pit was excavated to a depth of approximately 1.3m deep, which was limited by striking bedrock at approximately 0.7m.bgl. The bedrock was seen to be roughly stratified and broke up into fragments of 100-200mm thick. Fresh surfaces showed a hard, dark grey limestone and closer examination revealed lighter specular reflections from calcite- later shown to be crinoid fossils. The excavation released a foetid odour when the rock was fractured. One rock sample was a paler reddish-brown limestone but its horizon was not identified on site and was possibly from a small area. Overall, the rock appeared to be the mapped Friar's Point limestone. Weathering surfaces on the rock interface were red clay with no indications of tufa. This suggests that flows within the limestone from higher up do not exit from below at this low point, although the surfaces of the rock partings were moist.

The soils identified were red-brown, silty loam with no stones and a sharp discontinuity at approximately 0.4m in depth, a possible plough-pan effect or an old excavation. No gleying or mottles were noted indicated a lack of periodic waterlogging despite being known to pond.

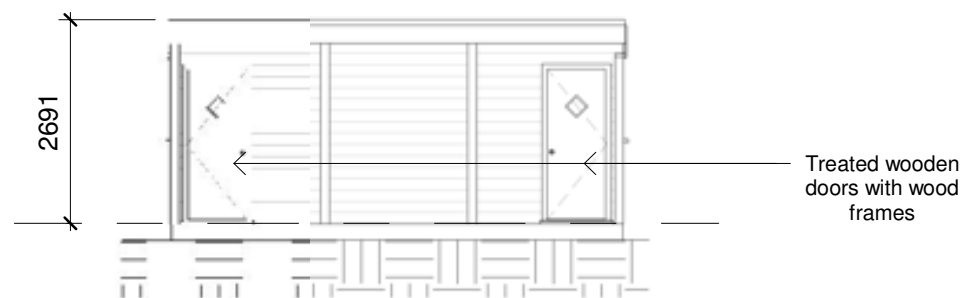
TEMPORARY STRUCTURE
(Pre-fabricated for minimal disruption to the area during installation)
Timber construction fishing amenities and services hut.

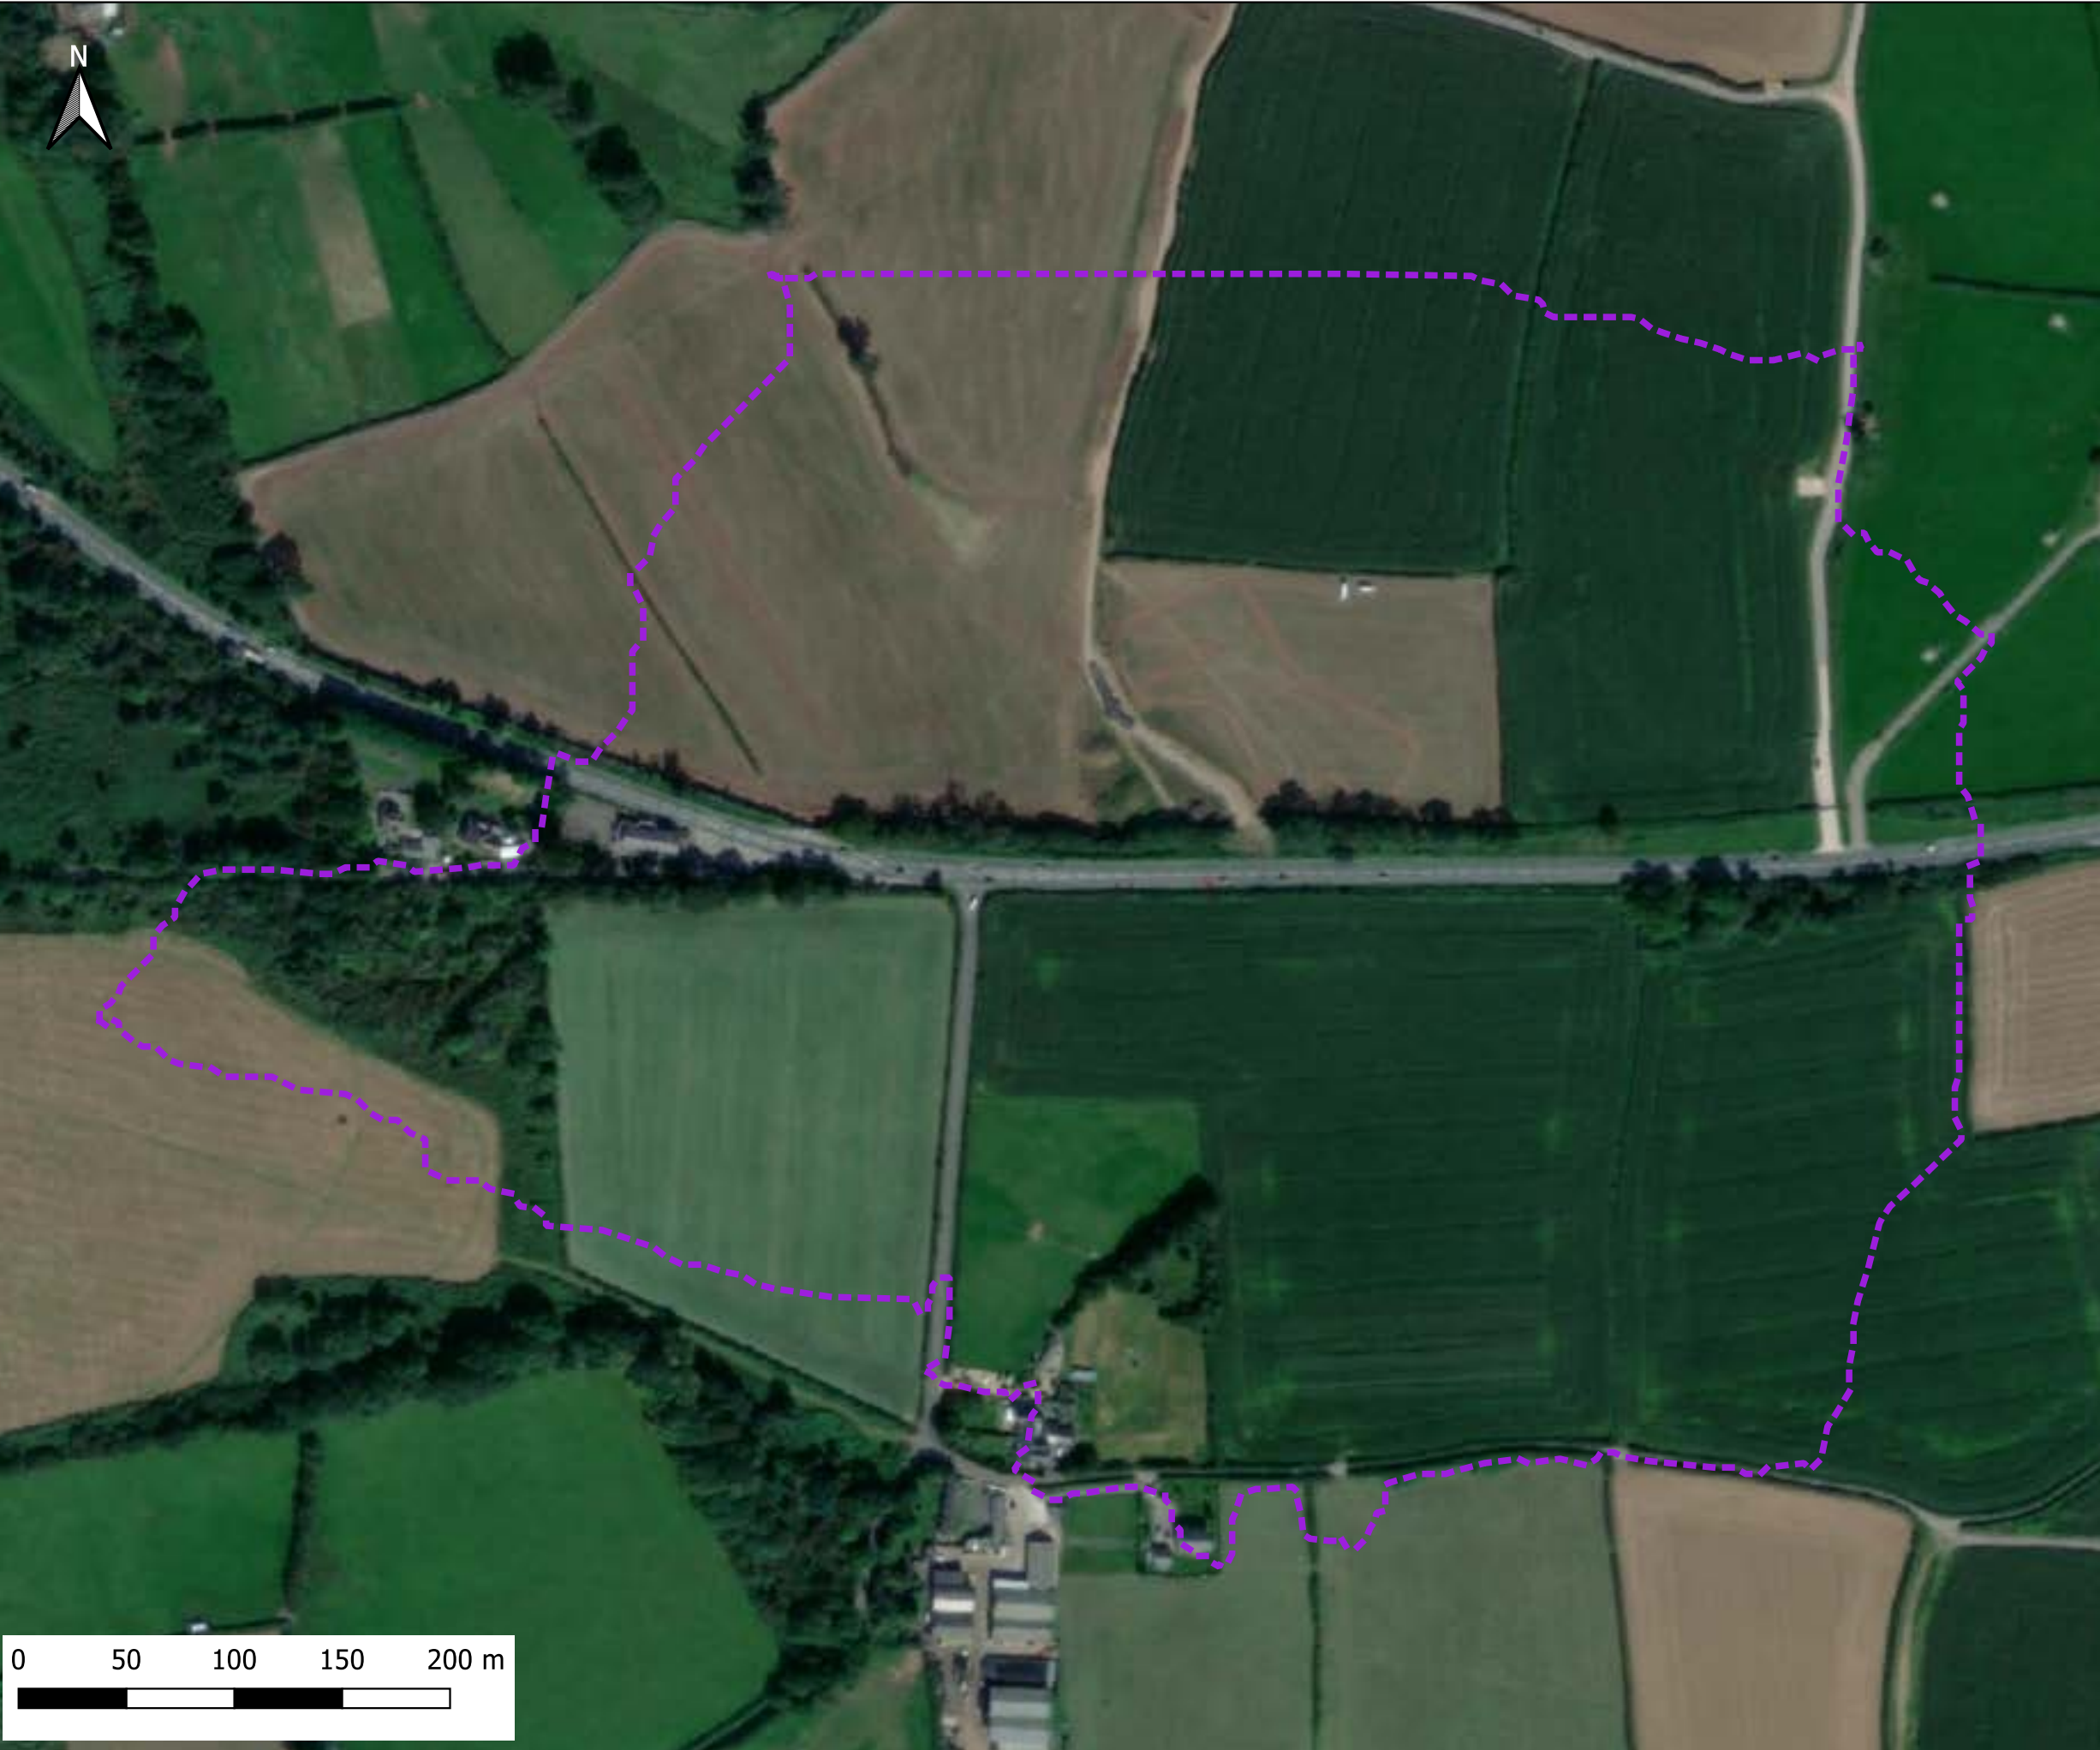
Pant Wilkin Sub-Catchment Location

LEGEND
 Pant Wilkin sub-catchment

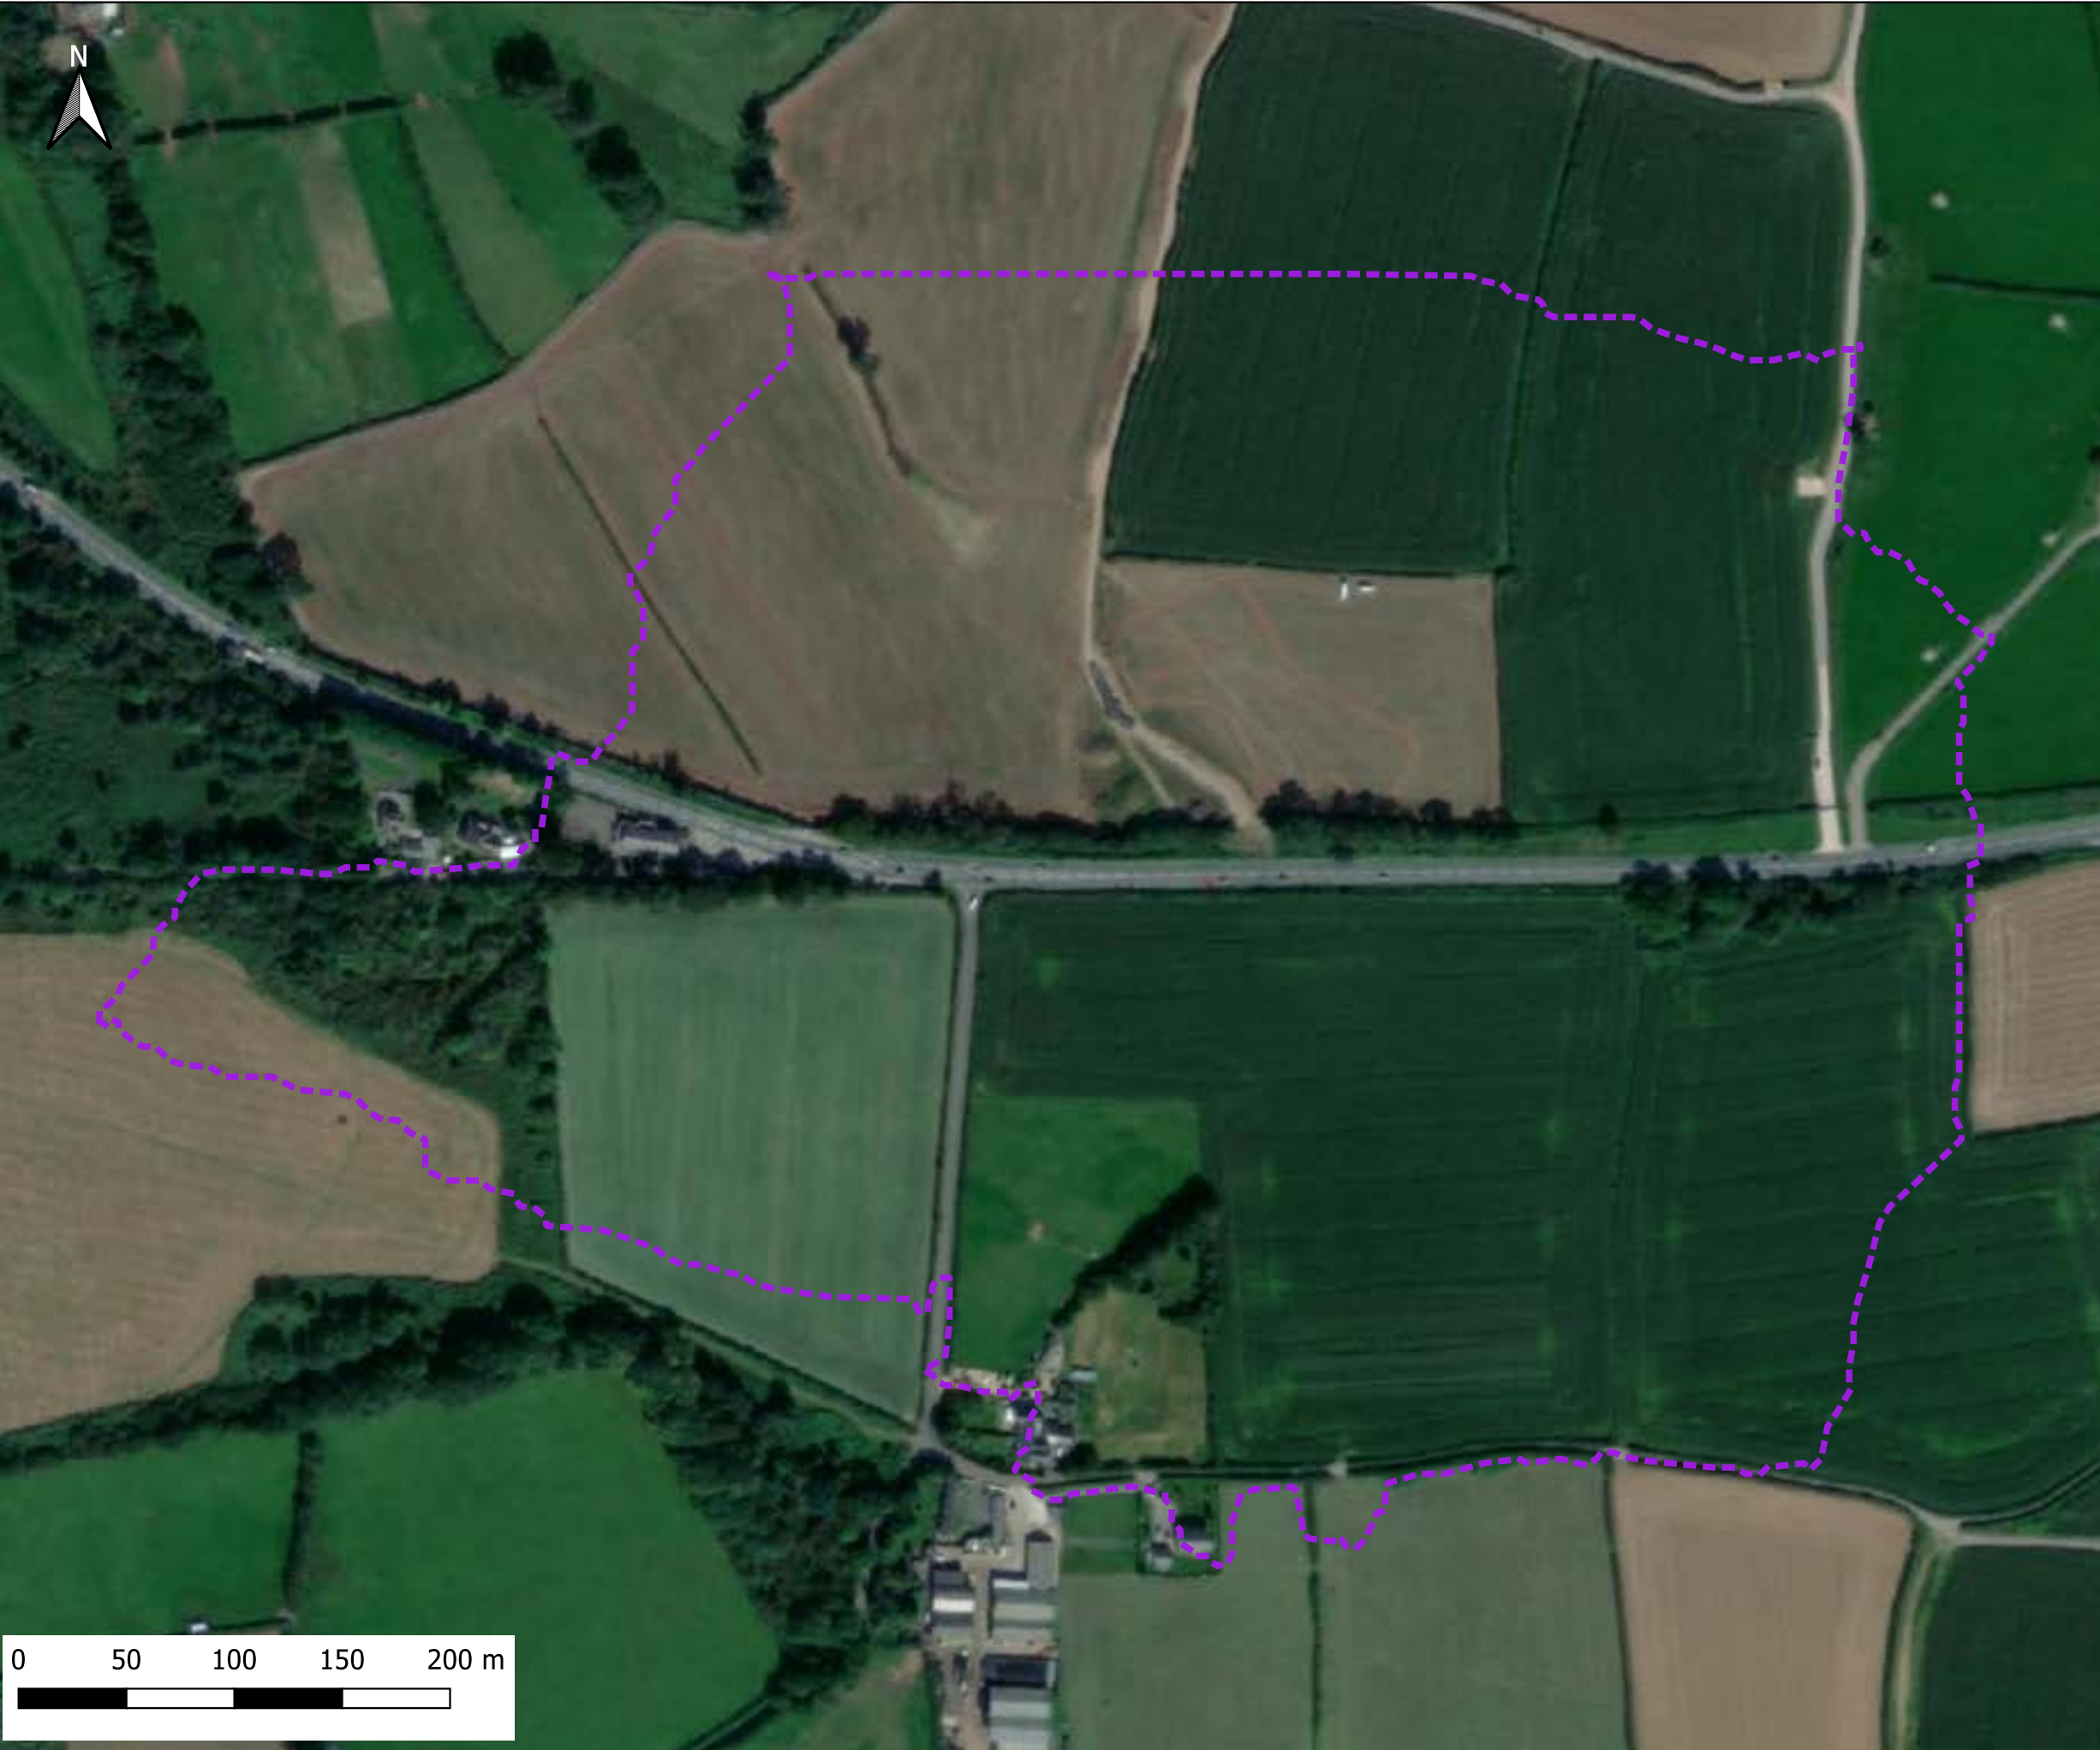
Figure 1 – Annotated SCALGO LIVE mapping showing a theoretical flow path

SCALGO Live has been used to generate a theoretical flow path map, as outlined in Figure 1. The key features identified have been confirmed or otherwise by on-site observations and anecdotal information provided by the Client, as follows:

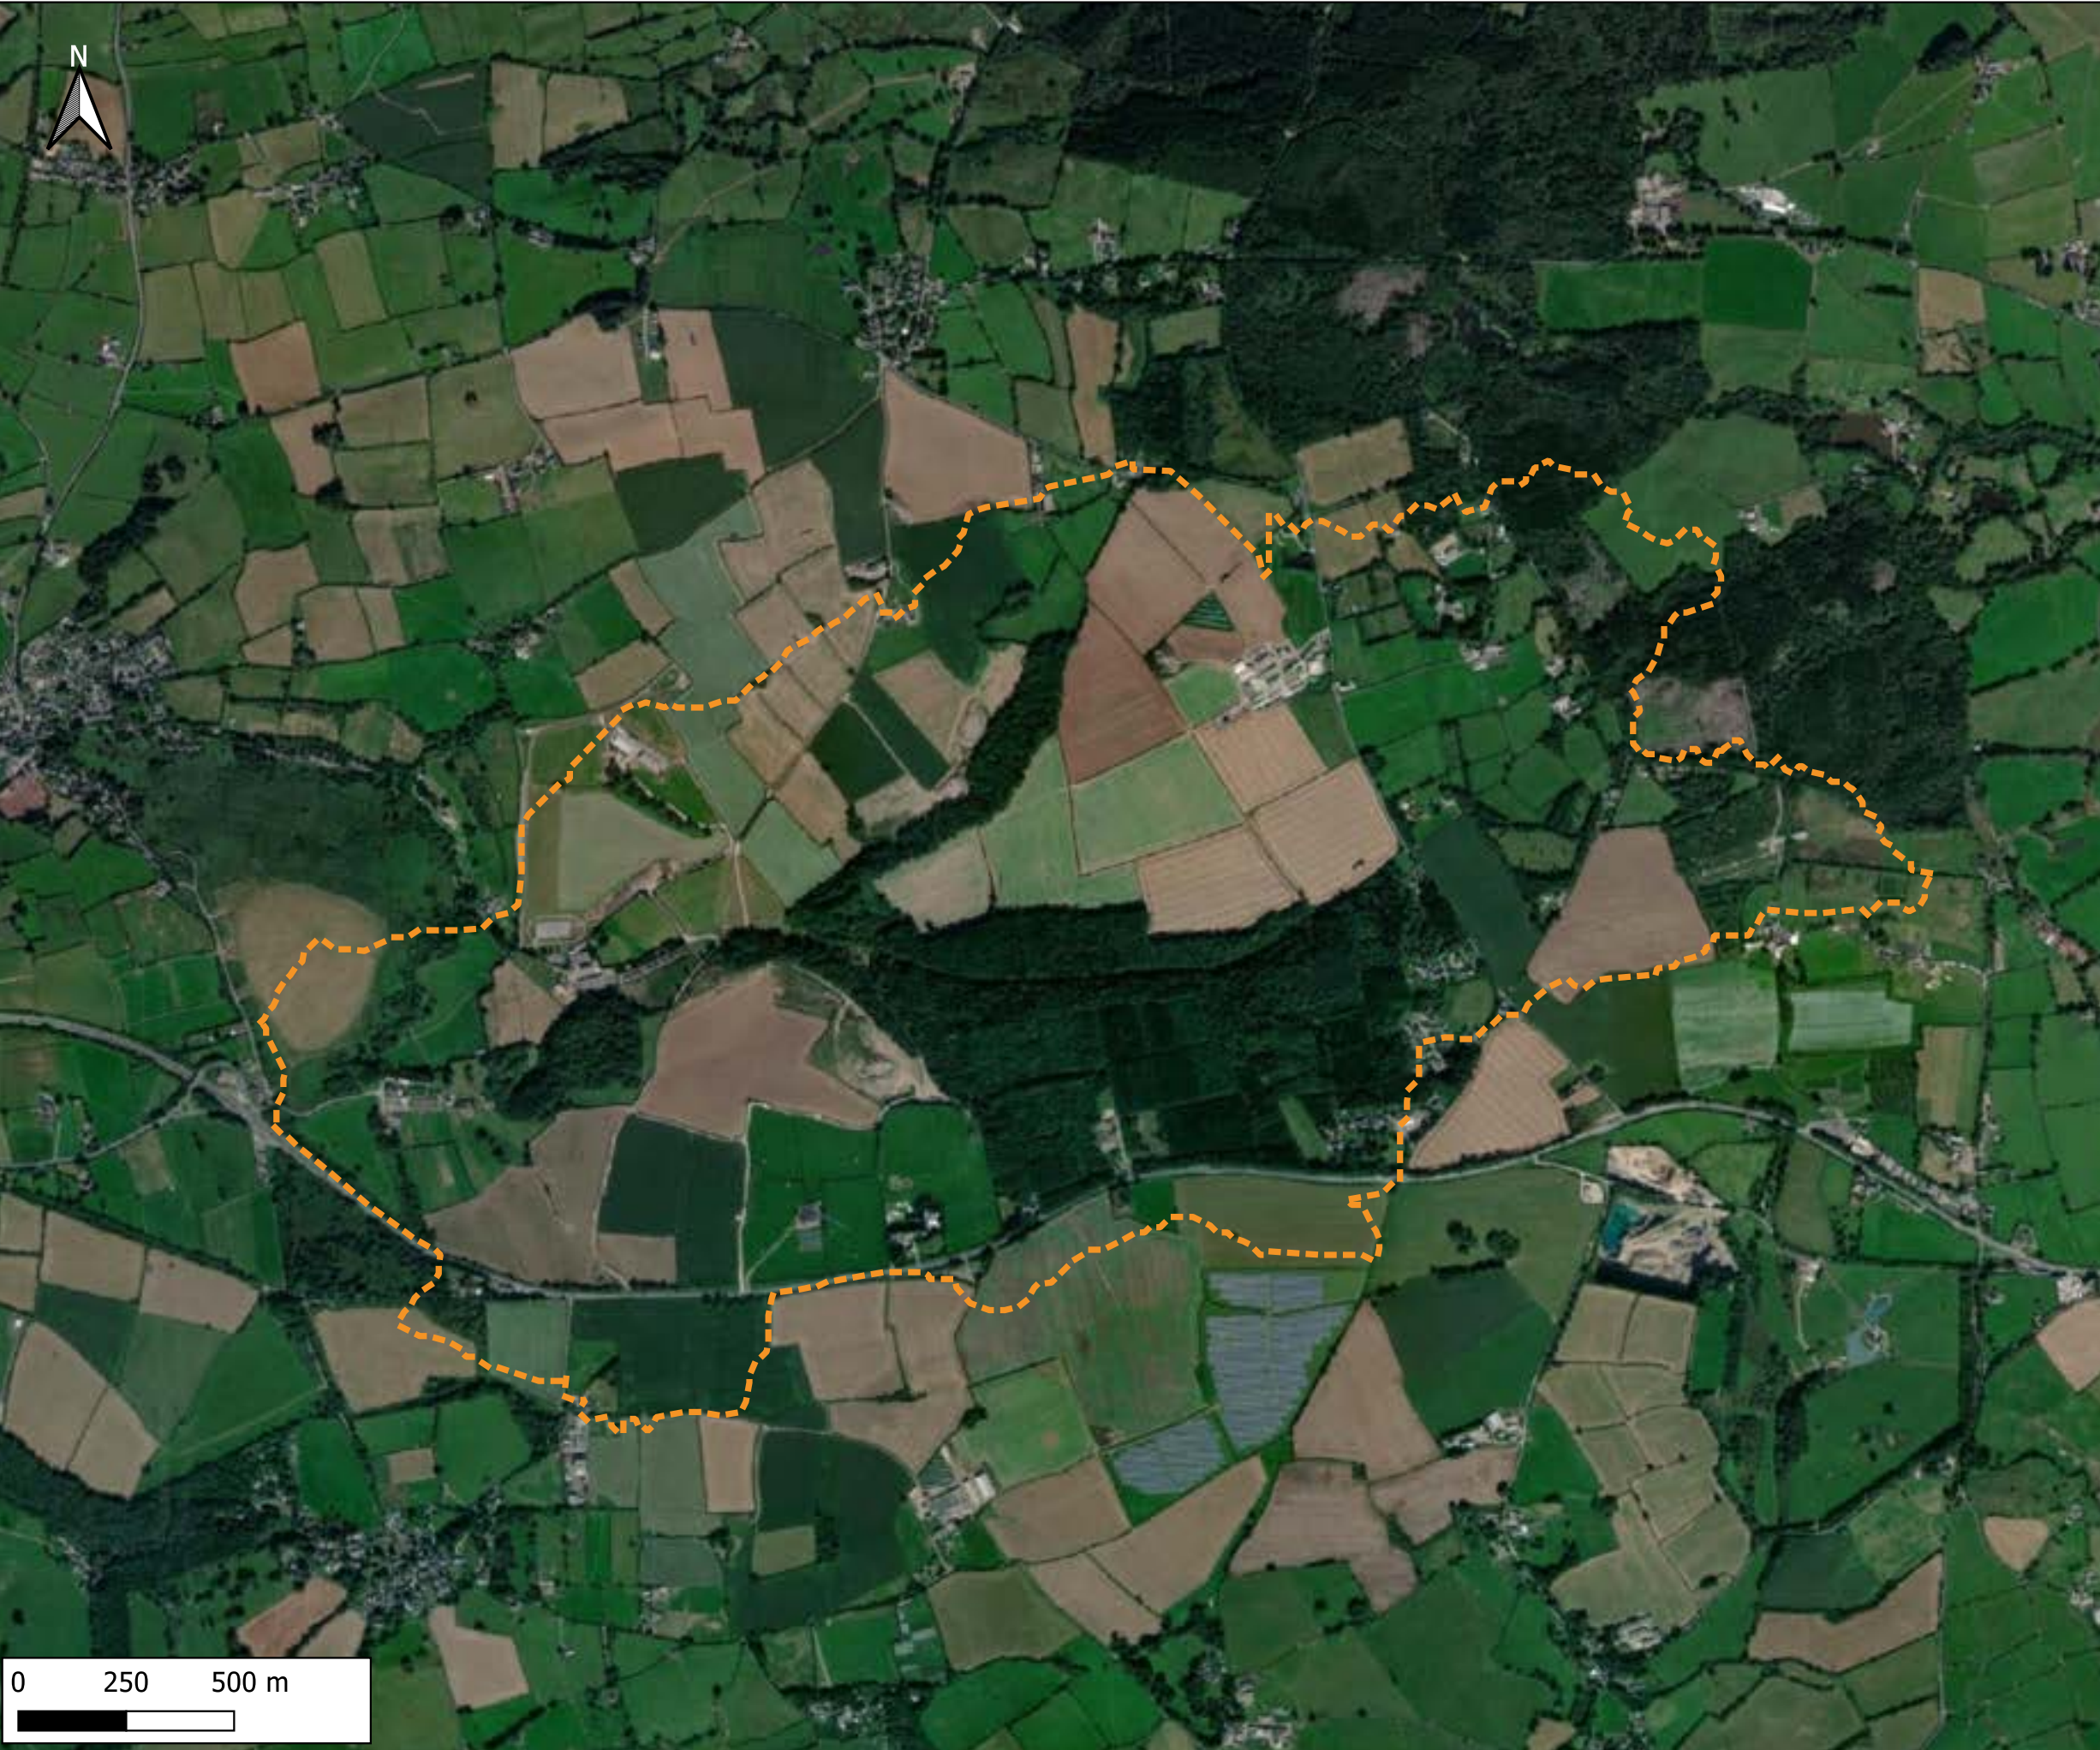
Nant Aberthin Catchment Location

LEGEND
 Nant Aberthin Catchment
